Effect of Black Powder contaminants on Gas metering equipment

Abstract

Contamination on Gas Metering Installations

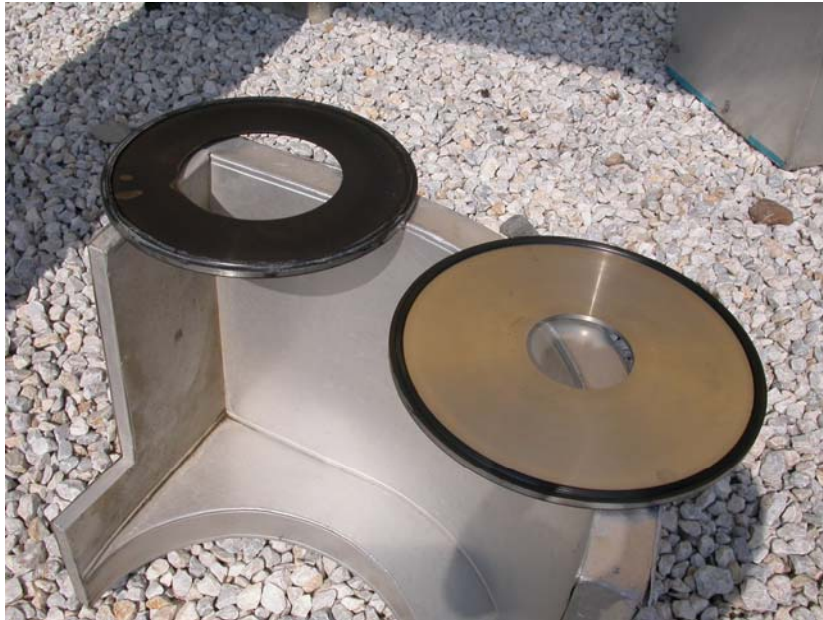
Gas quantity is measured at BMS by means of pressure differential devices (orifice). Heavy deposits of black powder were found on the upstream face of orifice plates. Figure 1 (*left side*) presents an orifice plate covered by a thick layer of black powder. This layer consists of black powder together with some oil or grease to give to the mixture adhesive properties. For comparison a clean plate is depicted also at Figure 1 (*right side*). This dirty orifice plate was removed from a metering line after about one month of operation. The upstream and the downstream face of the removed orifice plate had black powder deposits.

Figure 1. A contaminated with black powder (*left*) versus a clean (*right*) orifice plate. The bore diameter of the two orifice plates is different.

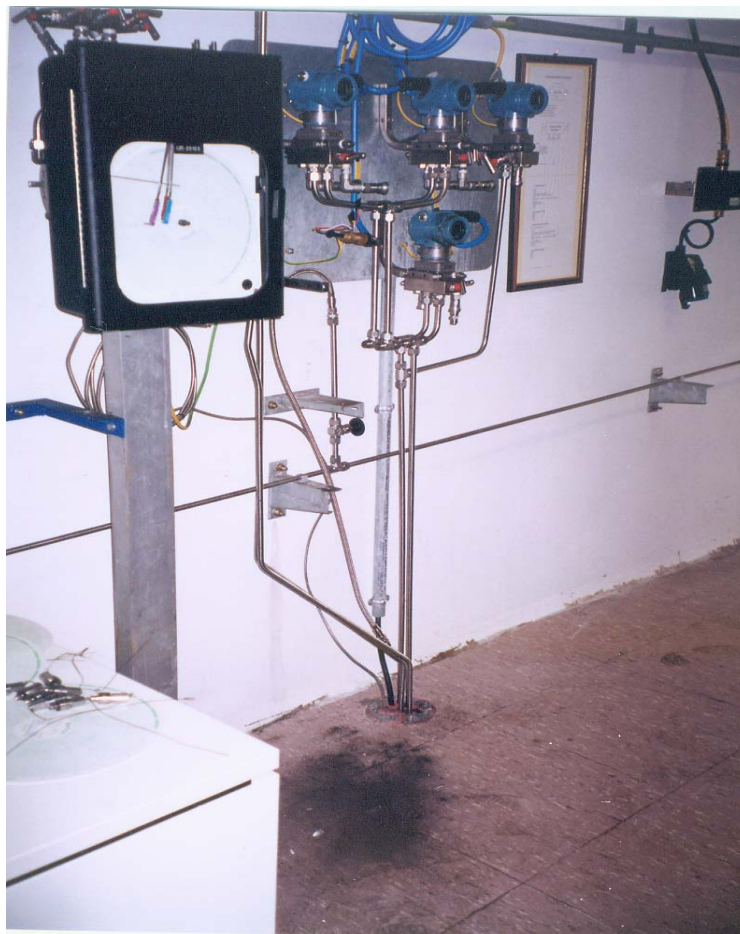
The instruments' arrangement of a metering line at BMS is depicted on Figure 2. At all metering lines the impulse lines feeding the pressure transmitters contained black powder. Also, all primary isolation valves of impulse lines contained black powder. Two isolation valves had to be changed for this reason. The 3-valve and the 5-valve manifolds of the fiscal pressure transmitters had sufficient black powder quantity on their valve seats. Some of these valve seats were permanently damaged.

Figure 2. Instrumentation of a gas metering line. Black powder removed from only one pressure transmitter is appearing on the floor.

Also, all manifolds and impulse lines were thoroughly cleaned during the monthly calibration process, before the re-installation and operation. The impulse lines were purged with air and

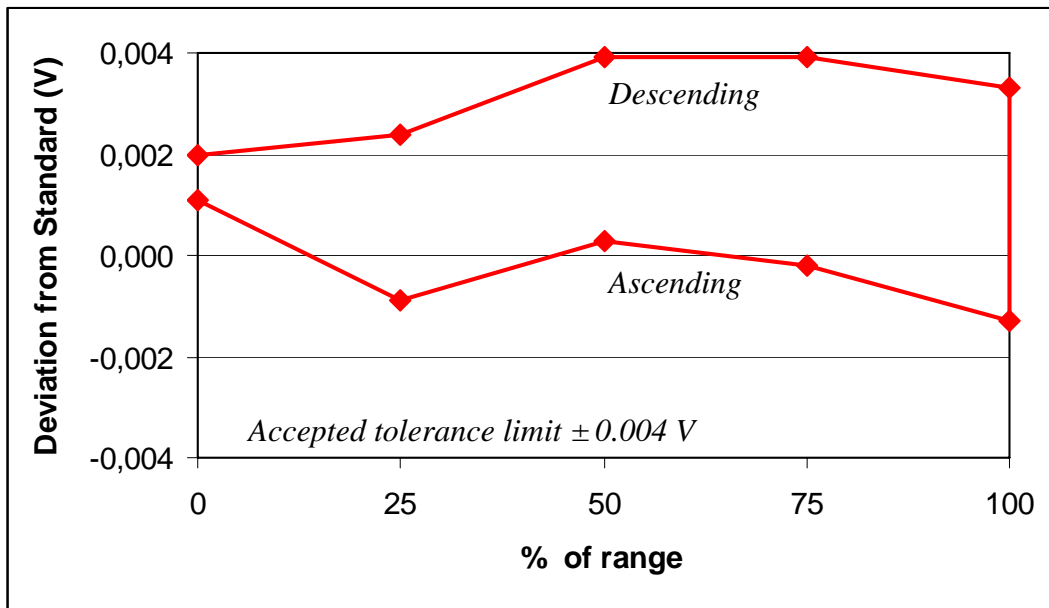
The performance of instruments was affected by the presence of black powder. Fiscal metering instruments were subjected to a regular calibration, on a monthly basis, to verify their performance. Such calibration results for a representative Differential Pressure transmitter (Tag No FT 20101C) are depicted on Figure 3. The calibration range of this transmitter is 0 – 500 mbar and its tolerance is ± 0.0040 V. It is evident that the instrument's output exhibit a large hysteresis (shift) between ascending and descending applied pressures. The recorded hysteresis at the maximum range (100% of range = 500 mbar) is particularly high (0.0046 V), although these calibration results are marginally acceptable. It should be mentioned that a clean transmitter has a negligible hysteresis at the same test.

Based on above findings, it is highly likely that this instrument may deviate beyond acceptable tolerance, when it is put back to operation. Indeed, when this specific pressure transmitter was put to operation, a high DP deviation alarm was raised at the corresponding flow computer. The DP transmitter was dismantled and inspected. The manifold and associated impulse lines were heavily contaminated by black powder. Figure 4 presents this pressure transmitter as found during the inspection. Both diaphragms of this transmitter were almost blocked by black powder deposits.

Figure 3. Calibration results of a Differential Pressure transmitter with black powder contamination. A large hysteresis is observed between response for ascending and descending applied values.

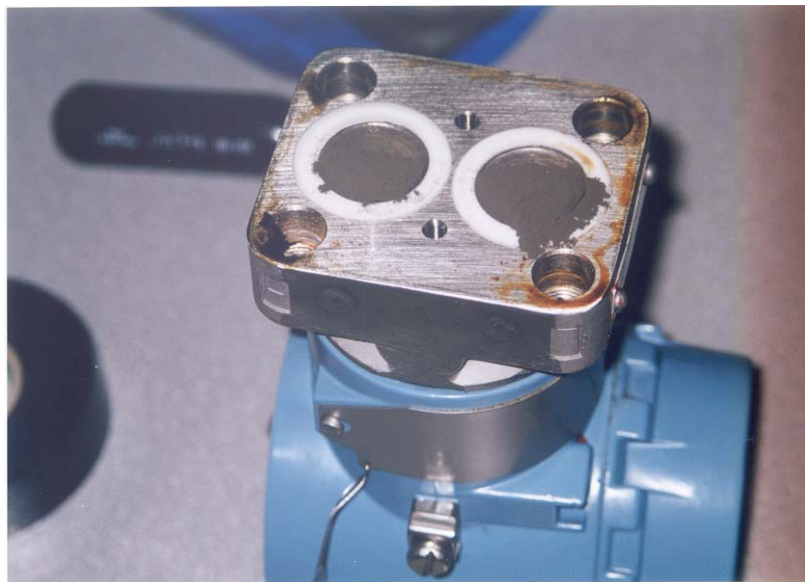
Figure 4. Pressure transmitter almost blocked by black powder deposits.

In order to avoid abnormal operation of the instruments and reduce possible errors of the gas measurement, a regular cleaning program was applied. All transmitters, found in situation similar to this depicted in Figure 4, were thoroughly cleaned by blowing compressed air. The diaphragms of the transmitters were carefully cleaned with acetone solution.

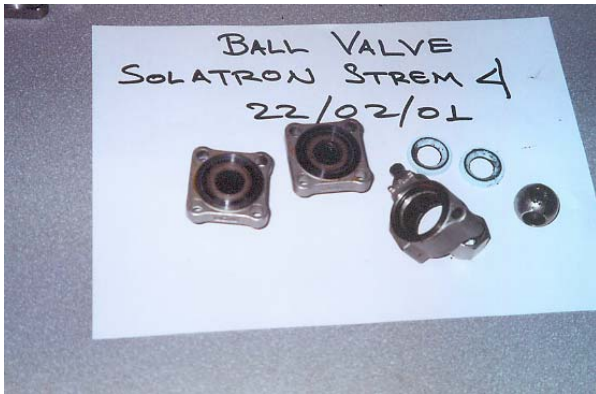
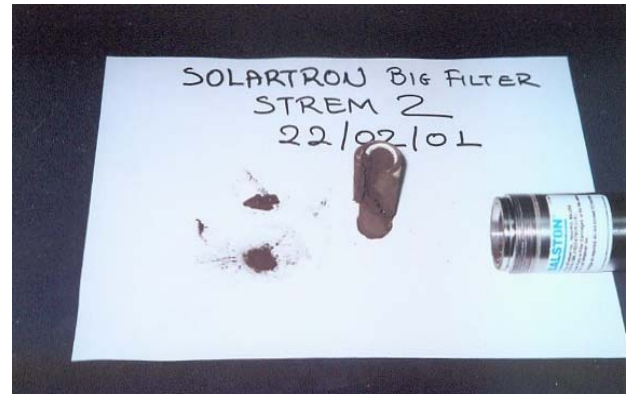
Figure 5 (*left*) depicts parts of a ball valve at the impulse line of an on-line densitometer. The seats of this valve were heavily contaminated by black powder. The inlet pressure filters of the densitometers were full of powder, as Figure 5 indicates (*right*). The low pressure internal filters were contaminated also and black powder had passed onto the sensitive vibrating cylinders of the densitometers. The densitometers were sent to the manufacturer's laboratories for maintenance. The manufacturer confirmed that the densitometers' sensors were contaminated with black powder.

Figure 5. *Left:* Parts of a ball valve at the feeding line of an on-line densitometer heavily contaminated by black powder.
Right: The inlet filter element of an on-line densitometer covered by black powder.

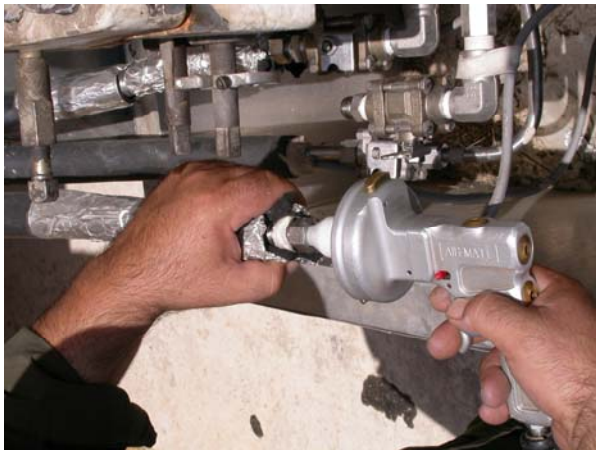
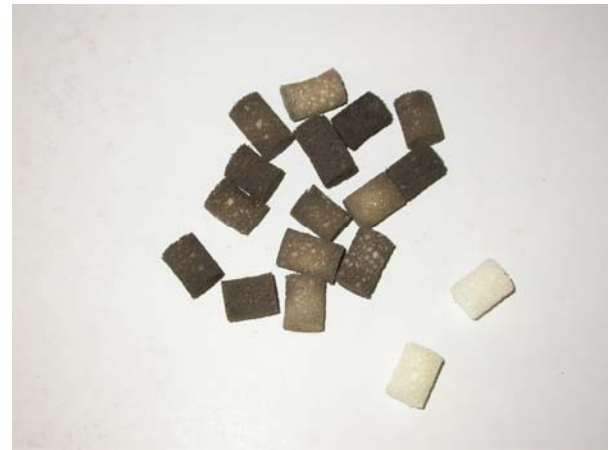
Figure 6. The pellet launcher (*left*) used to remove black powder from gas metering impulse lines, and the special pellets used (*right*). The white colour pellets were turned to black colour after one pass from an impulse line.

nitrogen. Additionally, a special air tool was used to push pellets of cylindrical sponges into the tubes of impulse lines. The special air tool is presented at Figure 6 together with the pellets for the cleaning of the internal surface of the impulse lines. The white colour special pellets were turned to black colour after just one pass from an impulse line. This air driven pellet launcher is suitable to remove contamination of hoses, tubes or pipes.
