## Study addresses black powder's effects on metering equipment

**Nikolaos A. Tsochatzidis**

*DESFA SA*

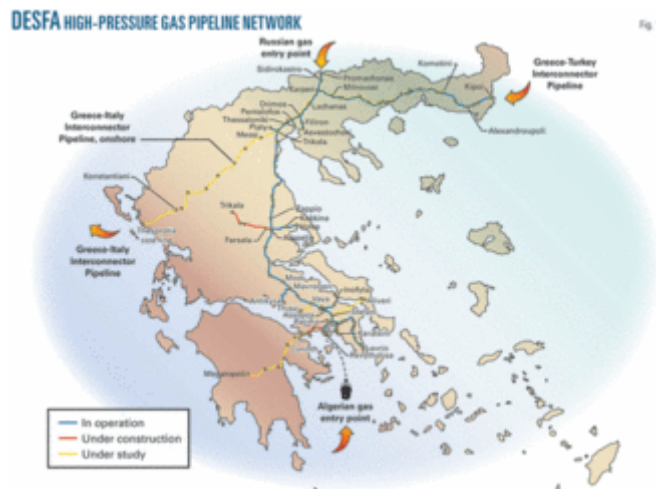
Fig. 1

The Hellenic Gas Transmission System Operator (DESFA) SA, founded in April 2007 as a wholly owned subsidiary of DEPA SA, operates, and is expanding, Greece's national gas transmission system (Fig. 1).

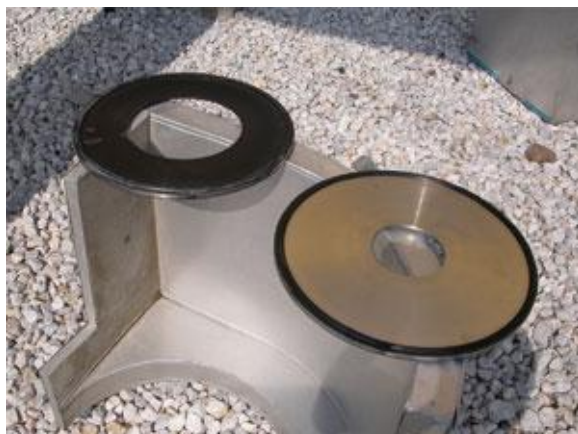
*Black powder thoroughly coated the orifice plate shown on the left of this photograph. A clean orifice plate provides contrast (Fig. 2).*

- **Orifice plates.** Pressure differential devices (orifice plates) measure the gas quantity at BMS. An investigation uncovered heavy black powder deposits on the upstream face of orifice plates. The left side of Fig. 2 shows an orifice plate covered by a thick layer of black powder. This layer consists of black powder together with oil or grease, which gives the mixture adhesive properties. The right side of Fig. 2 shows a clean plate. The operator removed the dirty orifice plate from a metering line after about 1 month of operation. Both the upstream and downstream faces of the removed orifice plate showed black powder deposits.

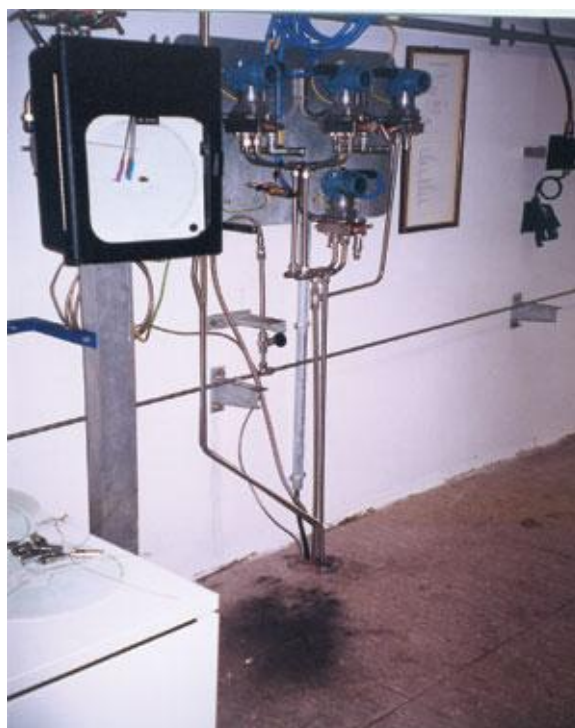
*Black powder from just one gas pressure transmitter lies on the floor beneath the transmitter assembly and metering instrumentation (Fig. 3).*

- **Impulse lines, instrument manifolds.** Fig. 3 shows the arrangement of instruments on a metering line at BMS. Impulse lines feeding pressure transmitters at all metering lines contained black powder, as did the impulse lines' primary isolation valves. Two isolation valves required changing. Enough black powder accumulated in some of the three-valve and five-valve manifolds at the fiscal pressure transmitters to cause permanent damage.

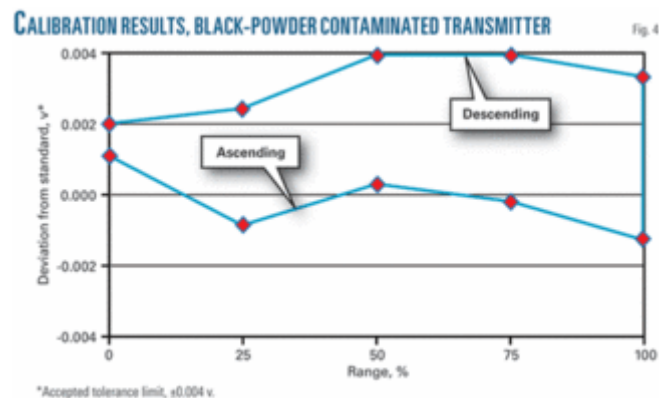
- **Influence on pressure measurements.** Regular monthly calibration performed to fiscal metering instruments verifies their performance. Black powder affected instrument performance. Fig. 4 shows calibration results for a representative differential pressure transmitter (Tag No. FT 20101C), with a calibration range of 0-500 millibar and a tolerance of  $\pm 0.0040$  v. The instrument's output exhibits a large hysteresis (shift) between ascending and descending applied pressures. The hysteresis recorded at the top of the calibration range (500 mbar) is particularly high (0.0046 v). These calibration results fall within the marginally acceptable range, but a clean transmitter shows negligible hysteresis in the same test.

Such metering instruments are highly likely to deviate beyond acceptable tolerance when put back in operation. When this specific pressure transmitter returned to operation, for instance, it triggered a high differential pressure (DP) deviation alarm at the corresponding flow computer.

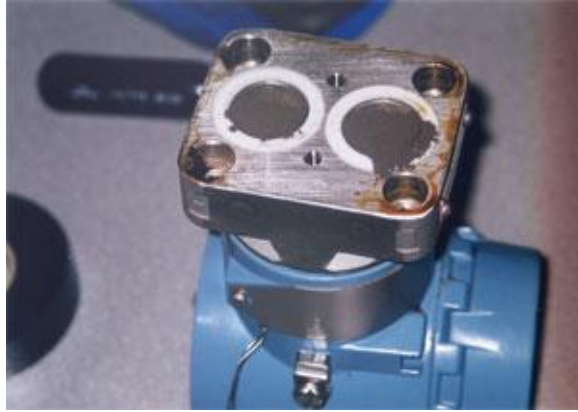
Operators dismantled and inspected the DP transmitter, finding the manifold and associated impulse lines heavily contaminated with black powder.

*Black powder has almost completely blocked this pressure transmitter (Fig. 5).*

Fig. 5 shows this pressure transmitter as found during inspection. Black powder almost completely blocked both the transmitters' diaphragms.

BMS operators applied a regular cleaning program to avoid abnormal operation of the instruments and reduce possible errors in gas measurement, cleaning all transmitters similar to that shown in Fig. 5 by blowing compressed air and the transmitters' diaphragms with acetone solution.

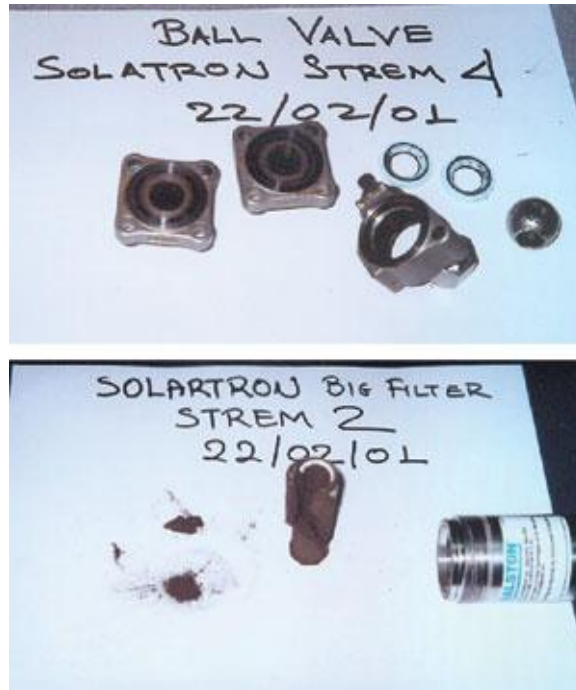
- **Online densitometers.** The left portion of Fig. 6 shows parts of a ball valve at the impulse line of an online densitometer. Black powder heavily contaminated the seats of this valve, filling the densitometer's inlet pressure filters (Fig. 6, right). Black powder also contaminated the densitometer's low-pressure internal filters, passing on to its sensitive vibrating cylinders. The operator sent the instruments to the manufacturer's laboratories for maintenance. The manufacturer confirmed that the densitometers' sensors were contaminated with black powder.

*The photograph on the left shows parts of a ball valve from the feed line of an online densitometer heavily contaminated by black powder. The right photograph shows the inlet filter element of a similarly contaminated online densitometer (Fig.6).*

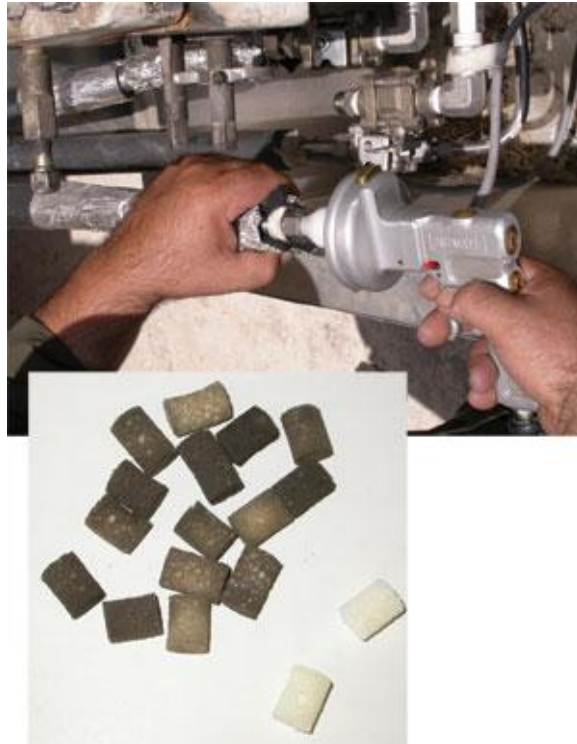
*A pellet launcher (left) removed black powder from gas metering impulse lines. The pellets used (right) turned black after just one pass through the impulse line (Fig. 7).*

Operators also began thoroughly cleaning all manifolds and impulse lines as part of the monthly calibration process, purging impulse lines with air and nitrogen. A special air tool also pushed pellets of cylindrical sponge into the tubes of impulse lines (Fig. 7). The white pellets turned black after just one pass through an impulse line.

The air driven pellet launcher can also remove contaminants from hoses, tubes, or pipes.
