## Methods help remove black powder from gas pipelines

**Nikolaos A. Tsochatzidis**

**Konstantinos E. Maroulis**

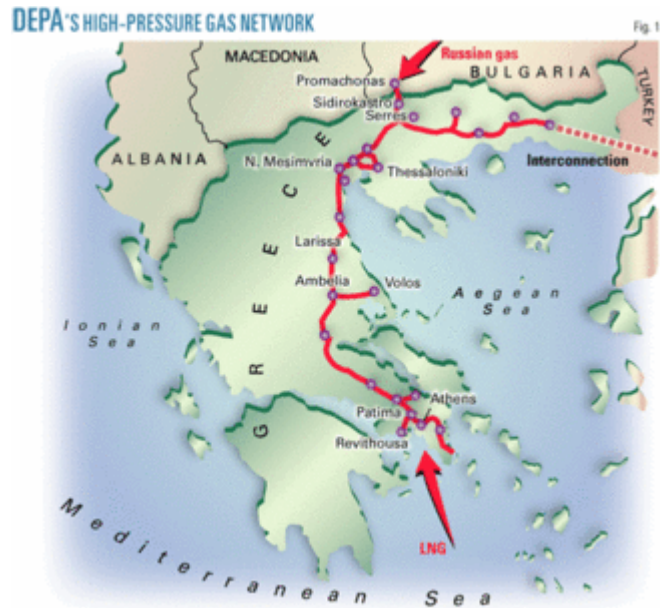
DEPA's high-pressure gas network (Fig. 1) first experienced operational problems caused by black powder in imported natural gas in March 1999. DEPA performed a pigging operation on the first 12 km of the Greek pipeline from the Bulgarian-Greek border at Promachonas to the border metering station, removing 1,000 kg of powder.

DEPA conducted a series of pigging operations in October 1999 to clean the first section of its pipeline from the border to the entrance of the border metering station. This 36 in. OD, 12-km section operated at a pressure of roughly 50 barg, with a designed pressure of 70 barg. Internal coating on all of DEPA's high-pressure pipelines (Fig. 1) facilitates gas flow.

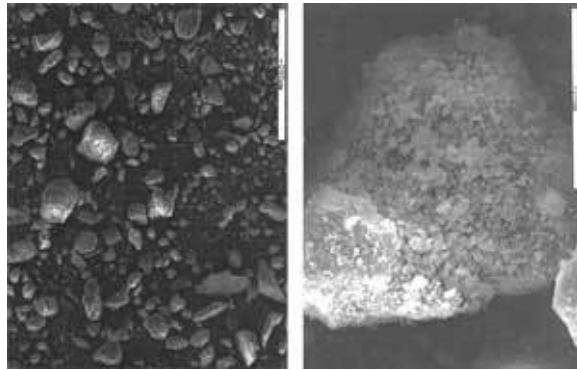
*Pictures of black powder through an electron microscope confirmed its amorphous nature, with a wide range of particle sizes present. Analysis detected both large particles and submicron flakes. Particles can shear easily and break into submicron sizes (Fig. 2).*

Fig. 2 presents two pictures of black powder from an electron microscope, confirming results of the particle size analysis reported on Table 1. Results of particle size analysis varied due to the amorphous nature of the powder. Analysis detected both large particles and submicron flakes. Particles can shear easily and break into submicron sizes, making filtration extremely difficult. Large particles stay in the filters, dropout vessels, etc., while smaller ones are carried downstream and tend to agglomerate due to their magnetic properties.

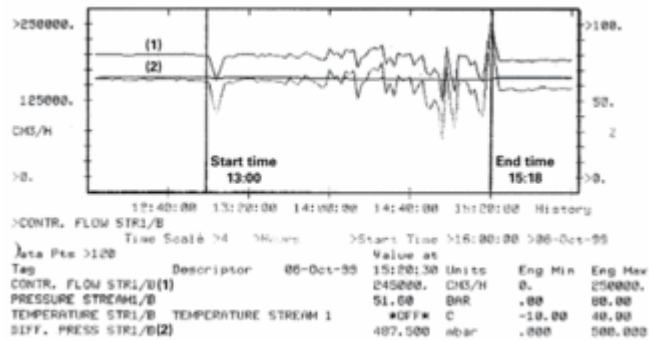
*Gas flow and differential pressure fluctuated during gauge pigging. Flow-fluctuation information is marked by (1) and includes the upper line in this screen shot. Differential-pressure fluctuation is marked by (2) and includes the lower line. Pigging began at 13:00 and ended at 15:18 (Fig. 3).*

A gauge pig, equipped with flexible caps and an aluminum gauge plate, continued the operation. This pig moved at an average velocity of 1.4 m/sec. Fig. 3 depicts gas flow and differential pressure traces during this pigging, as logged at the distributed control system of DEPA's border metering station. A downstream metering device provided differential pressure measurements. Large fluctuations at the second half of the pig's route show that the pig swept along and carried over a large quantity of powder. Indeed, 4,500 kg of black powder landed in the pig receiver trap.

Monitoring pig movement, using flow or pressure traces (or other mechanisms), is essential for a reliable indication of how much powder the pig carried.

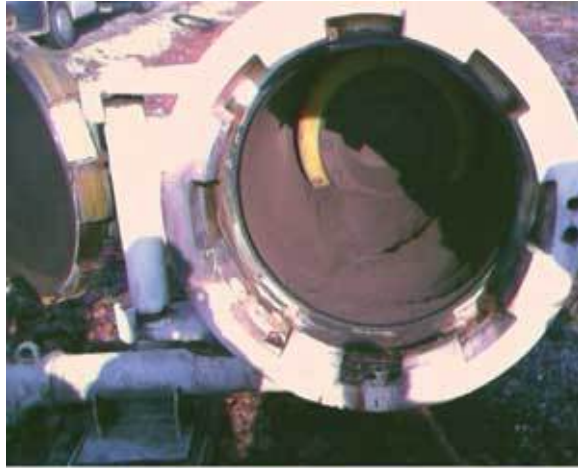
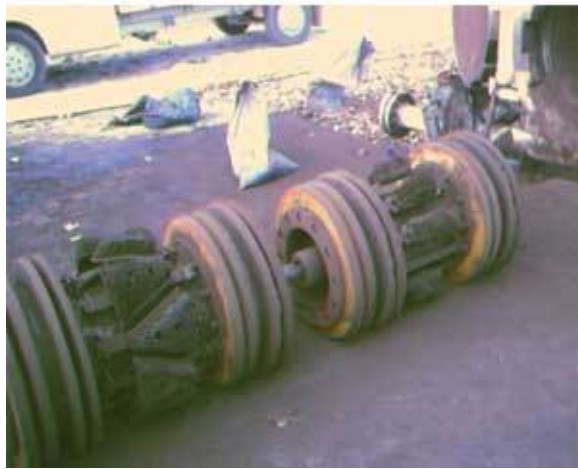
*Dual module bidirectional pigs with brushes continued to remove large amounts of black powder even after other techniques had been applied. The interior of the pipeline on the Bulgarian side of the border was not protected with coating (Fig. 4).*

Pigging continued from 2000 to 2003 at DEPA's pipeline and also upstream, in Bulgarian territory, where dual module bidirectional pigs with brushes were also used, the interior of that pipeline not having been protected with coating. These operations removed a large amount of powder (Fig. 4).

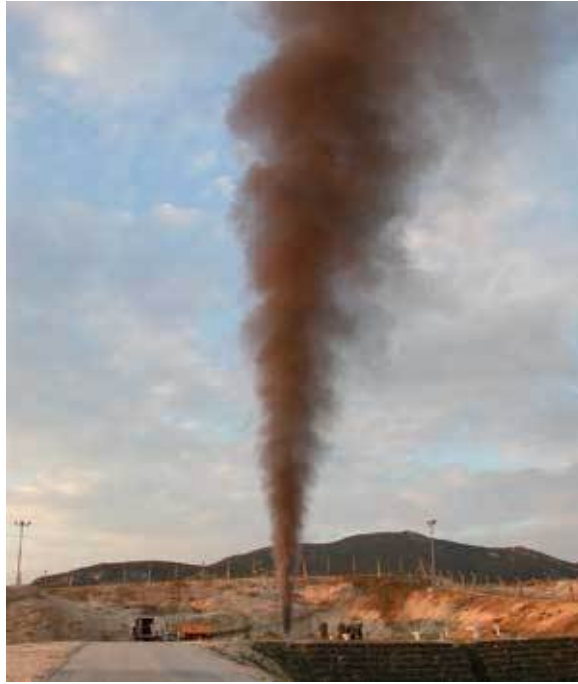
*DEPA purged the valve station at the entrance of the border metering station with gas after pigging in order to dispose of any remaining powder and prevent rapid clogging of the cartridge filters, venting large amounts of black powder in the process (Fig. 5).*

DEPA purged the valve station at the entrance of the border metering station with gas after this round of pigging to dispose of any remaining powder and prevent rapid clogging of the cartridge filters. Gas vented during these blow downs contained large amounts of black powder (Fig. 5).

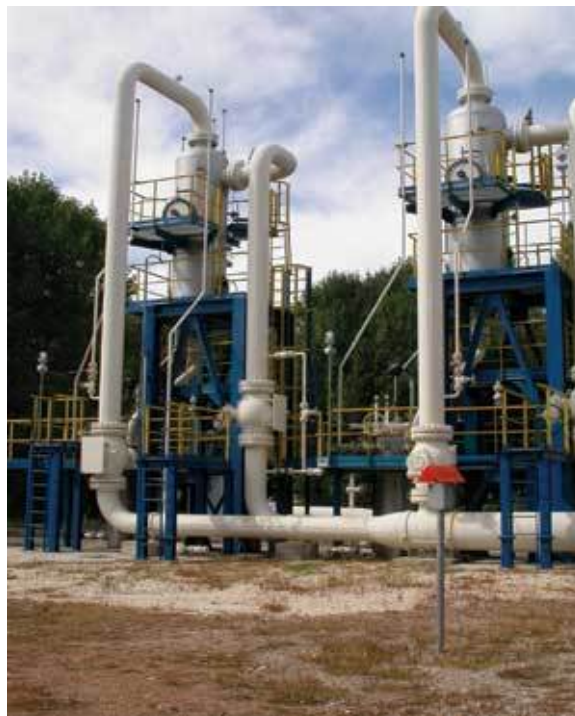
*In order to protect its downstream system from black powder, DEPA installed two cyclone (centrifugal) filtration facilities at the start of its network next to the Bulgarian border. Use of these filters enhanced the effectiveness of trap filters further downstream (Fig. 6).*

In order to protect its downstream system from black powder, DEPA installed two cyclone (centrifugal) filtration facilities (Fig. 6) at the start of its network next to the Bulgarian border. These filters separate 99% of contaminants larger than 5  $\mu\text{m}$ . Each cyclone uses a dedicated online dust collector vessel.

These cyclone separators removed black powder very efficiently. During second-half 2003, the cyclones removed roughly 7,000 kg of black powder; a quantity capable of clogging the downstream cartridge filters several times, thereby preventing normal gas offtake.

The separators continuously gathered the black powder in high-pressure dust collectors placed below the cyclones. Once full (roughly 1,000 kg), the separator would depressurize to remove the debris. In addition to the dry powder, the cyclones separated compressor oil and water from the gas stream.
